# South Jetty Sediment Processes Study, Grays Harbor Washington: Evaluation of Engineering Structures and Maintenance Measures

April 2003

Final report

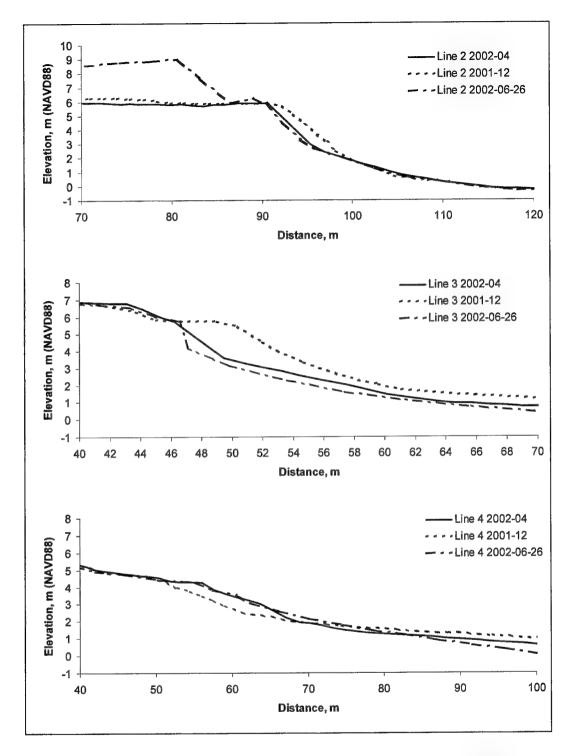
Profiles measured in December 2001, April 2002, and June 2002 at Transects HMB2, HMB3, and HMB4 (see Figure 8 for location) are shown in Figure 16. Transects HMB2 and HMB3 are in the gravel transition zone and Transect HMB4 is just beyond the eastward limit of the extended gravel zone. Comparison of the June 2002 survey of Transect HMB2 with the previous surveys illustrates the amount of material placed in the breach fill area during the emergency repair in May 2002. Transect HMB2 shows a net horizontal recession of approximately 1.5 m between 2- and 6-m elevation with most of the erosion occurring between December and April. Transect HMB3 shows a net recession of up to 4 m and lowering of the profile at all elevations below 6 m. Transect HMB4 shows a net accretion of the profile above the elevation of 2 m between December 2001 and April 2002.

Beach profiles and median grain size in the gravel transition are responding to wave action. The profile change analysis shows that the profile adjustment is orderly around the Half Moon Bay shoreline. Changes that have occurred at Transect HMB4 suggest that the beach at that location is receiving sediment from updrift (Transects HMB2 and HMB3) to the west. The back beach is currently at the natural angle of repose for the sediment and, therefore, not at a long-term equilibrium position. At lower elevations on the beach profile, the gravel-sand mix results in a lower beach slope. Higher on the beach profile, there is a higher proportion of gravel, and the beach steepens. A longer series of observations is required to more fully evaluate the gravel transition performance.

Figure 16. Profiles at Transects HMB2, HMB3 in gravel transition and Transect HMB4 east of transition

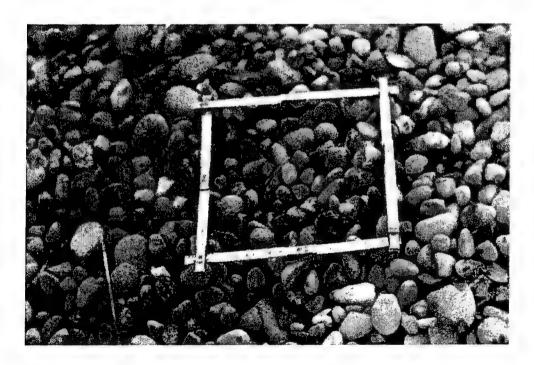
Figure 18. Transition gravel near el 12 ft above mllw, Transect HMB3, 14 January 2002

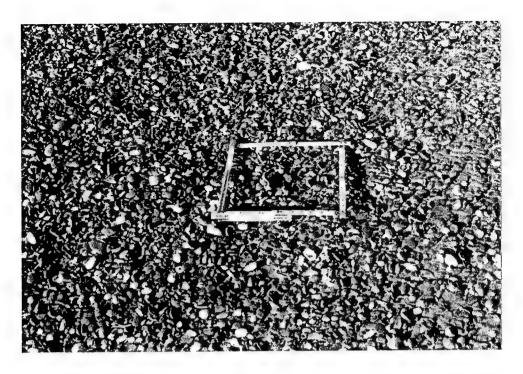
Figure 19. Transition gravel mixed with beach sand on lower profile, Transect HMB3, 14 January 2002

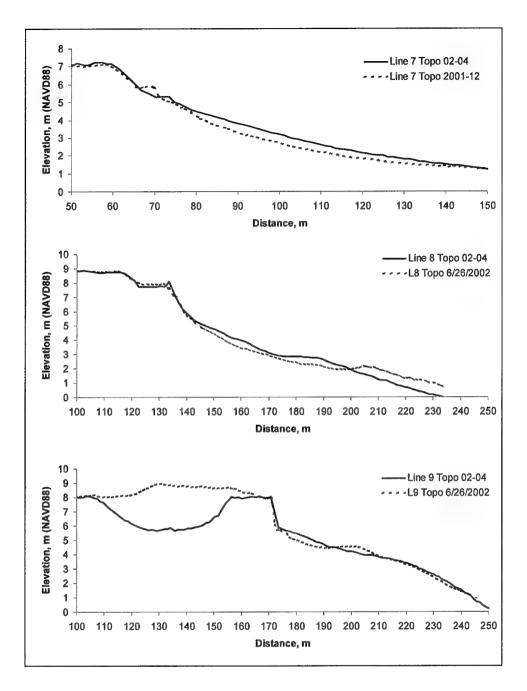
Figure 21 shows profiles at Transects HMB7 to HMB9 in December 2001 and April 2002 in the revetment fill section of the beach. Figure 12 shows the complete profile including bathymetry. All of the profiles have a steep scarp between elevations of +4 and +8 m, NAVD88. At the eastern end (Transect HMB9), the beach has a steep (1V:13H) slightly convex upwards foreshore that transitions to a broad gently sloping shelf (1V:240H) at approximately elevation -4 m, NAVD88 and extends at least 600 m seaward. To the south and west, the profiles at HMB8 and HMB9 become progressively more smoothly varying and concave upwards, and the scarp is less developed.

Figure 21. Beach profiles at Transects HMB7-9 above 0 m elevation

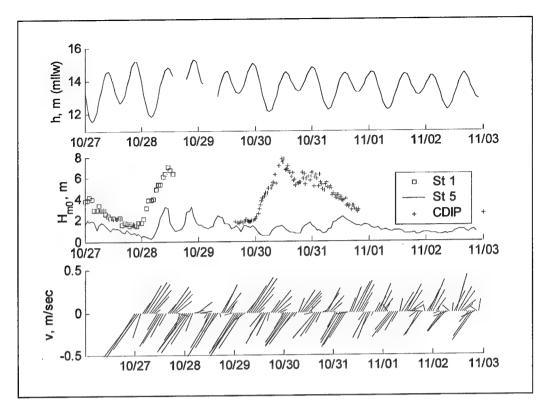
Time series of current vectors at sta 5 during a storm between 27 October and 2 November 1999 are shown in Figure 31. Similar time series at HMB1 and HMB3 for a storm that occurred 10-15 March 2002 are shown in Figure 32. Despite the large waves, the mean current at sta 5 is dominated by tidal forcing and oscillates between northeast and southwest on flood and ebb tide, respectively. Peak ebb and flood currents at sta 5 are capable of eroding sediment from the bed. The net current is ebb dominated and directed southwest. Although there is tidal period modulation of the current at HMB1, the current speeds also increase and decrease with wave height. Current vectors during the storm are directed northeast approximately parallel to the shore. Currents are generally less than 0.1 m/sec except at the peak of the storm. At HMB3 the currents are significantly weaker (< 0.1 m/sec) than at HMB1, with net current to the northeast.

Figure 31. Time series of depth h,  $H_{m0}$ , and current vectors at sta 5 during a 1999 storm

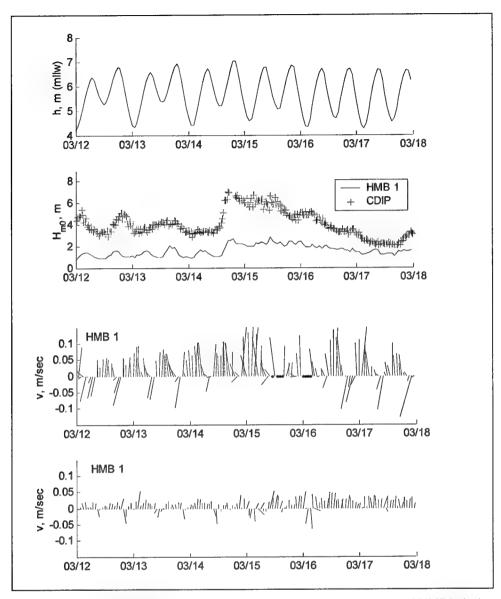
Figure 32. Time series of h,  $H_{m0}$ , and current vectors at HMB1 and HMB3 during a 2002 storm

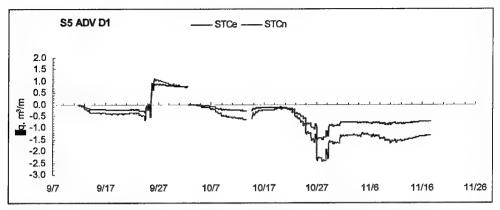
Figure 33 shows cumulative time series of the easting and northing components of the total load sediment flux according to the van Rijn formula at sta 5. The results indicate that the transport due to steady currents is episodic, responding mainly to large waves that entrain large quantities of sediment. The cumulative flux calculations indicate a net transport to the west-southwest over the period of deployment at sta 5. Tidal period fluctuations between northwest and southeast transport are apparent in the time series. The cumulative transport to the west-southwest is consistent with an ebb-dominant current that prevails on the south side of the Grays Harbor entrance. Although the measurements do not indicate a significant wave-induced sediment transport at sta 5, it is likely that wave-induced currents and transport increase significantly in proximity to the shoreline at Half Moon Bay.

Figure 33. Cumulative time series of easting and northing components of sediment transport between September and November 1999 calculated with van Rijn formula and input parameters measured at sta 5

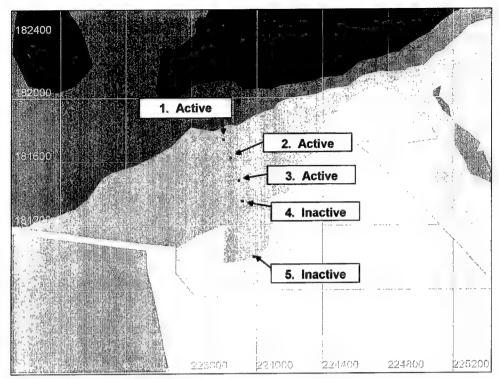
To evaluate sediment disposal in Half Moon Bay, five separate sediment-loading sites were assessed. No sediment activity was observed for medium sand at those sites nearest the shore. Figure 40 shows the locations of the inactive and active loading sites. Figure 41 shows a sequence of frames at 2-hr intervals for medium sand at the third position in Figure 40, which coincides approximately with the position of nearshore berm placement in May 2002.

Figure 40. Location of active and inactive sites for sediment sources in PSed module for medium sand in Half Moon Bay

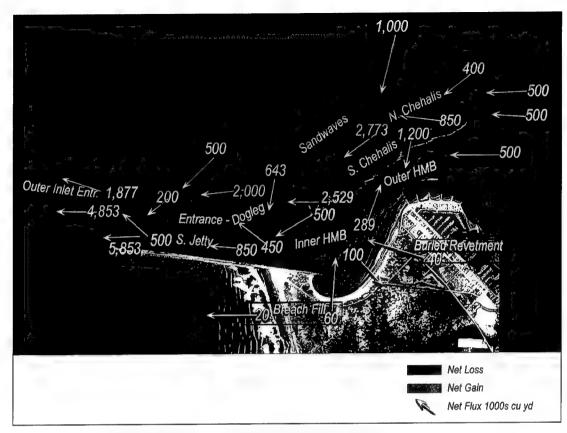
The product of polygon area and integrated net bed elevation change is the net change in the volume of each polygon. The net volume change over the period 1996 to 2002, dredging and disposal data, and the conceptual understanding of coastal processes were applied to develop a sediment budget in the Sediment Budget Analysis System (SBAS) (Rosati and Kraus 2001) (Figure 43 and Table 9). Values listed in Table 9 arise directly from the SBAS and do not represent physical accuracy, which is estimated to be in the range of  $\pm 30$  percent. Polygons for the buried revetment area at Point Chehalis and the breach fill at the south jetty were also included in the sediment budget. It was found through sensitivity testing that varying the number of polygons and the position of the polygon boundaries in the area through a reasonable range did not significantly alter the results. It is assumed on the basis of the sediment transport analysis previously presented that the net transport direction in the southern half of the inlet adjacent to Half Moon Bay is from northeast to southwest. Therefore, most of the net volume fluxes of sediment between cells are concluded to be in this direction. Sediment is transported from inner Half Moon Bay to outer Half Moon Bay to the northeast as a result of wave-induced alongshore and acrossshore currents and by tidal currents.

The polygons in the northeast portion of the study area (sand waves, Point Chehalis Reach, and South Chehalis polygons) show a net loss of sediment, whereas polygons in the southwest portion of the study area show net gain (inner

Figure 43. Sediment budget for Half Moon Bay/south jetty area developed from net morphology change between 1996 and 2002

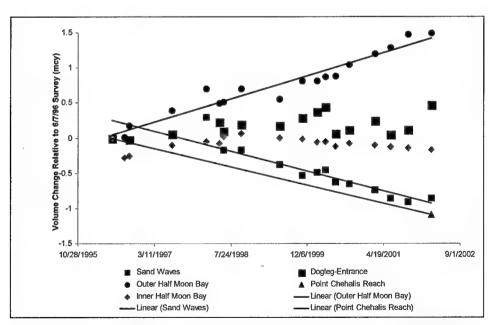
and outer Half Moon Bay, entrance reach, south jetty, and outer inlet). Time series of volume changes in each polygon were computed by differencing the 21 bathymetric surfaces over the period 1996 to 2002 (Figure 44). Only points in which the survey covered at least 90 percent of the total polygon area are included in the calculations and shown in the time series. Also shown in Figure 44 are linear trend lines fit to the data for the sand waves, outer Half Moon Bay, and Point Chehalis Reach polygons. The time series confirm that the general pattern indicated in the net bed elevation change map are consistent with the temporal trends in the data. The sand waves and Point Chehalis Reach polygons lose sediment through time while the outer Half Moon Bay polygon gains sediment relative to 1996. Inner Half Moon Bay and the entrance reach show no significant trends towards erosion or accretion, although the entrance reach exhibits cycles that reflect persistent shoaling and annual maintenance dredging. The volumes summarized in Table 9 indicate the overall area has a small positive budget. The small positive budget is mostly attributed to the large volume (approximately 11 million cu yd) of dredged sediment disposed in the area that counters the erosion of sediment by waves and tidal currents from the inlet.

Figure 44. Time series of volume changes in erosion-accretion zones relative to 7 June1996 survey

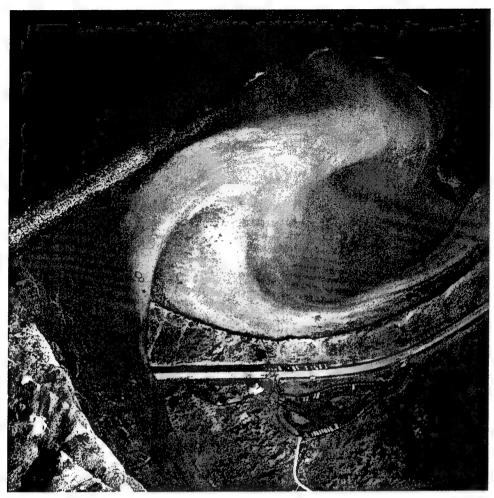
Figure A7. Breached area at Grays Harbor south jetty, 2 February 1994

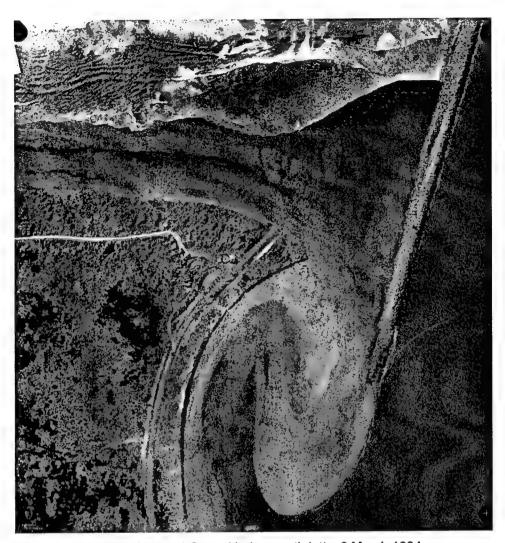
Figure A8. Breached area at Grays Harbor south jetty, 6 March 1994

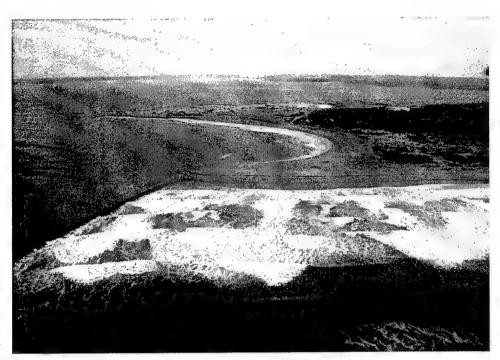
Figure A29. South jetty, looking east, 18 March 1999

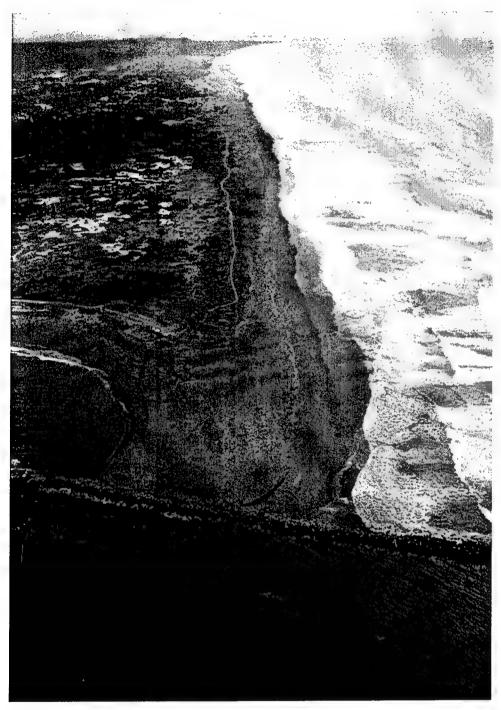
Figure A30. South jetty, looking south, 18 March 1999

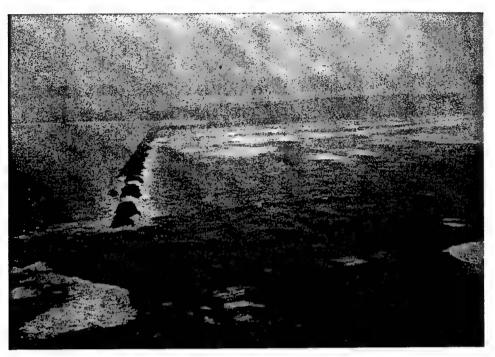
Figure A31. South jetty, looking east, 25 March 1999

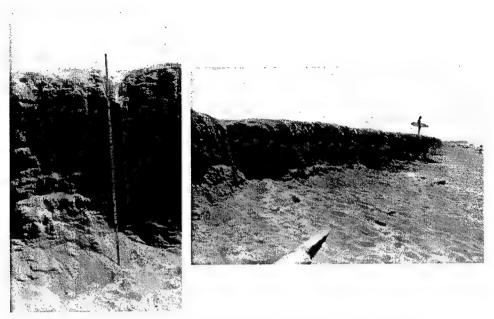
Figure A43. South Beach scarp near south jetty (scarp height is 5 ft), 24 August 1998

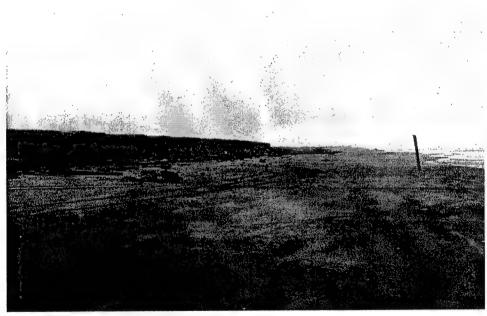
Figure A44. South Beach, 21 January 1999; pipe marks former location of park rest room

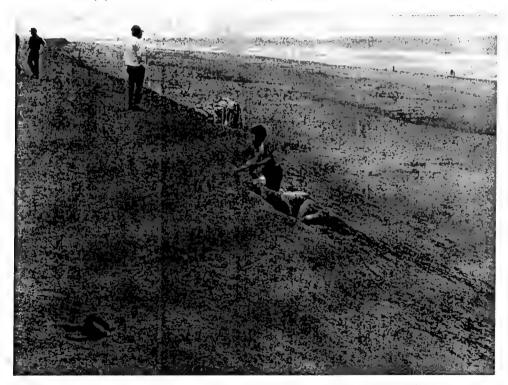
Figure A46. South Beach from dune renourishment, 20 August 2002

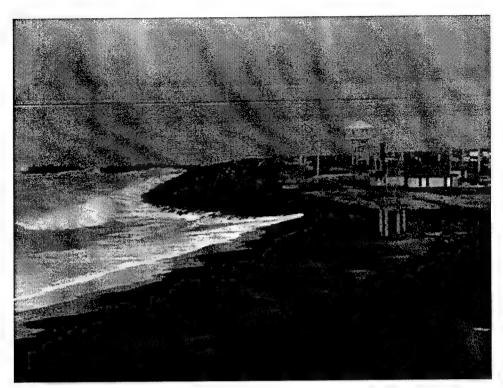
Figure A51. Half Moon Bay shoreline and northwest of Point Chehalis revetment, 1 February 2002

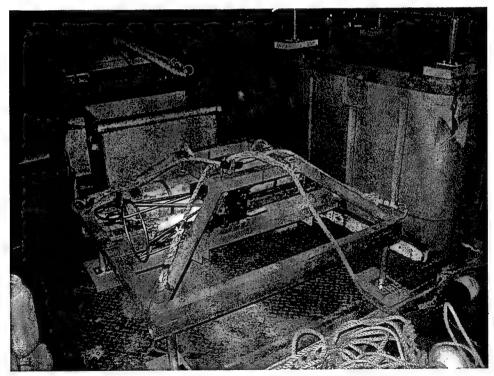
Figure A52. Wave gauge deployed in Half Moon Bay, 6 March 2002
